## Upper Thomas Fork Creek Stream Bank Stabilization Projects

## Kinsey Corral Relocation and Riparian Fencing Project

## Perrine Coulee Irrigation Return Flow Settling Ponds and Wetlands Projects

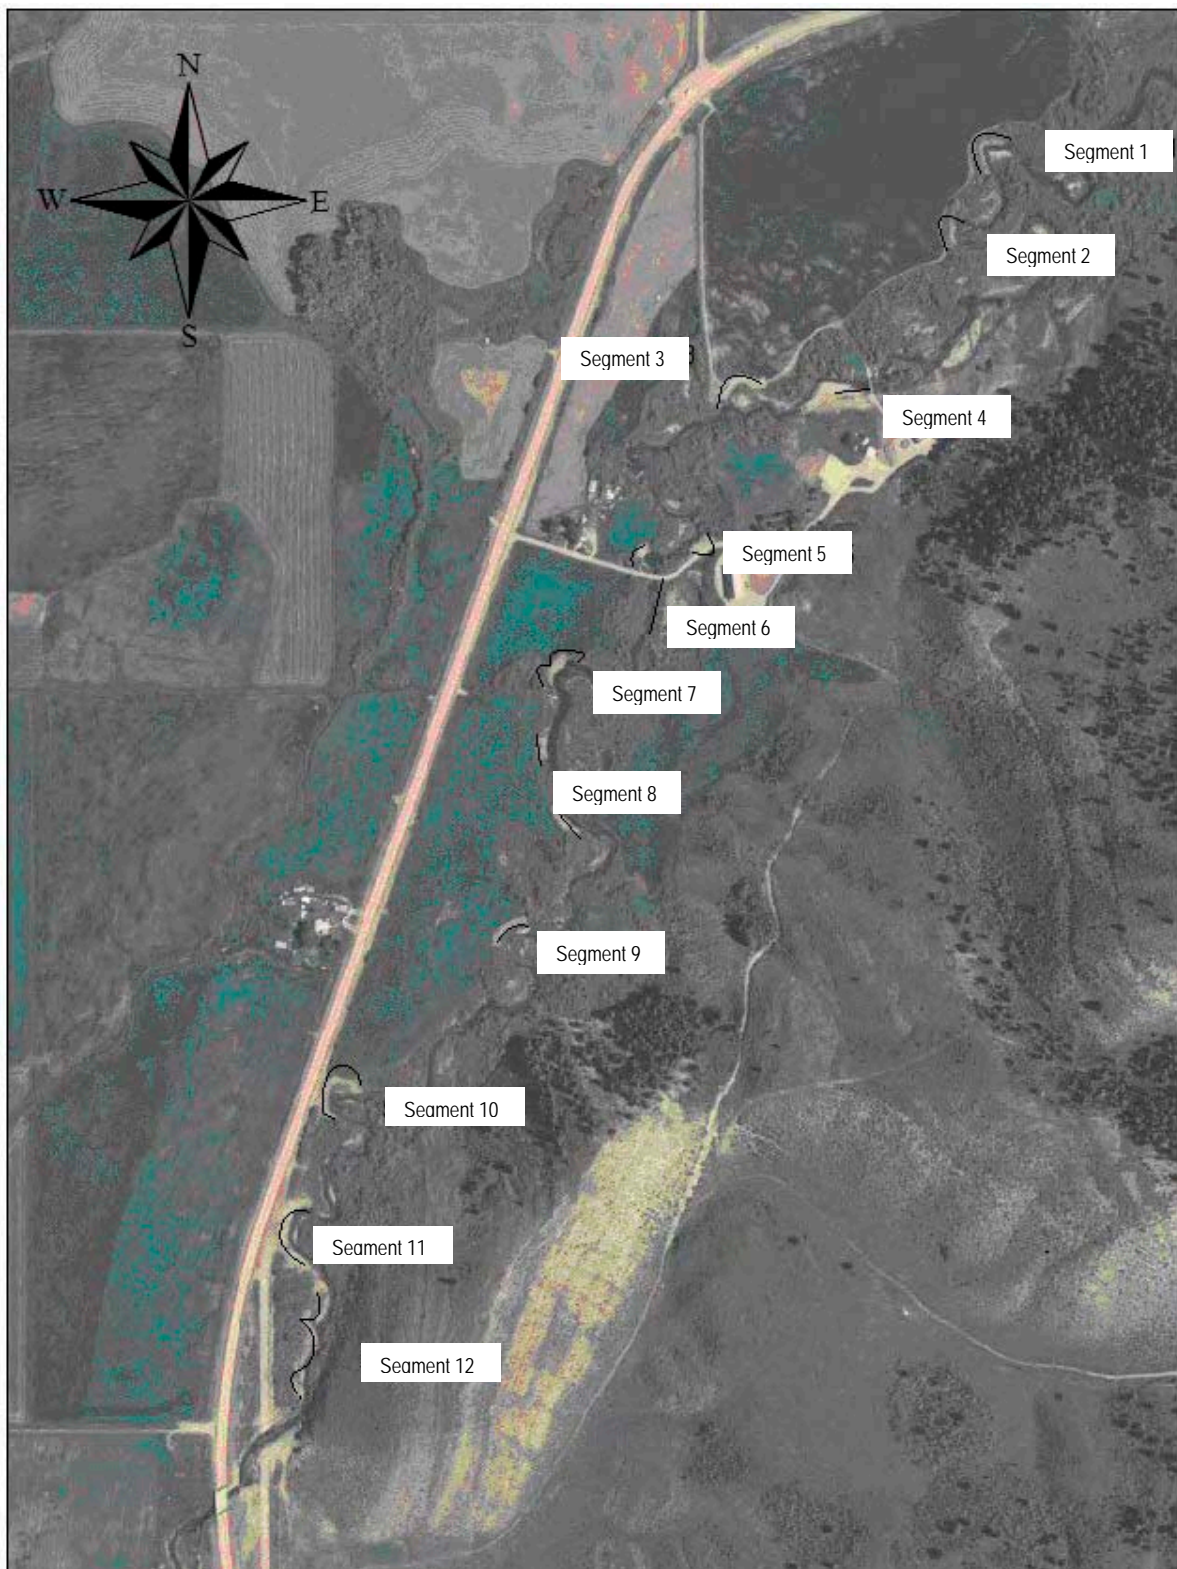
Figure 37. Segments treated along Thomas Fork on property owned by John Carricaburu.

The results section includes a narrative of the condition of BMPs after implementation and the monitoring information. Each treated area is considered as a segment and a description of type and amount of BMP implemented at each treated area is reported. Monitoring results include: water chemistry samples, photo points and surveyed cross sections. Segment reaches have been plotted on an aerial photo of the area (Figure 37).

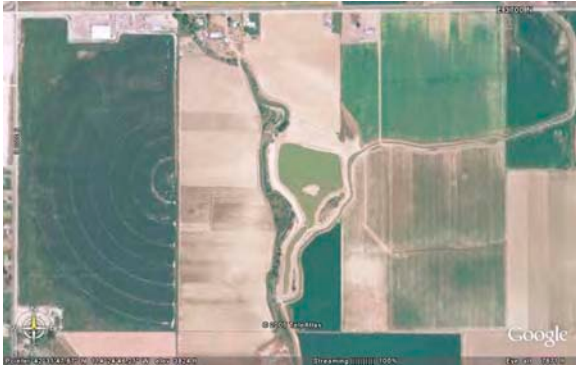
Figure 49. Main Perrine Coulee Wetland (Wetland located in center of photo)

Water quality monitoring data collected during the irrigation season of 2005, shows that the Main Perrine Coulee Wetland (Figure 49) is successful in removing pollutants from surface water. Water samples were taken above and below the wetland. This reduction is expected to decrease even further with the construction of the new Lower Perrine Coulee Wetland.
